**ornateinteriors**

## Project: Restoration of Georgian Residence

The restoration of a privately-owned Grade II listed Georgian mansion presented an exceptionally intricate challenge to the Ornate Interiors' team.

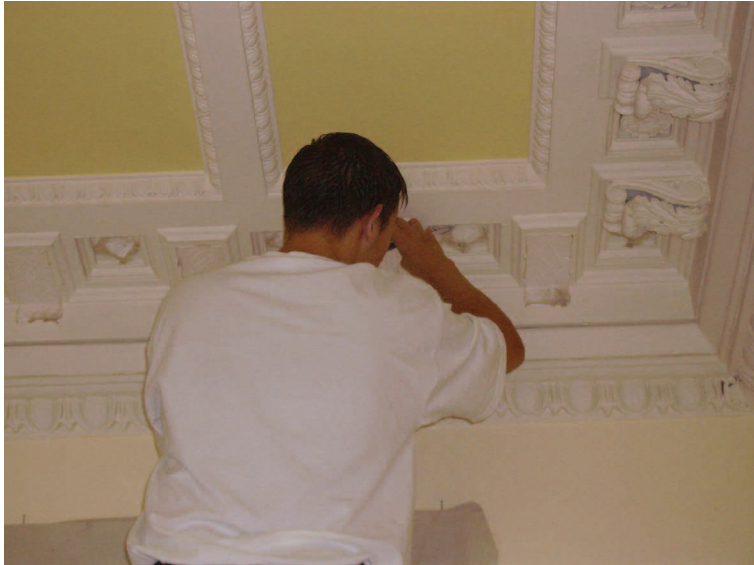
Paul Malyon removing enrichments.  
The paint was removed in our workshop,  
then modelled and reset.

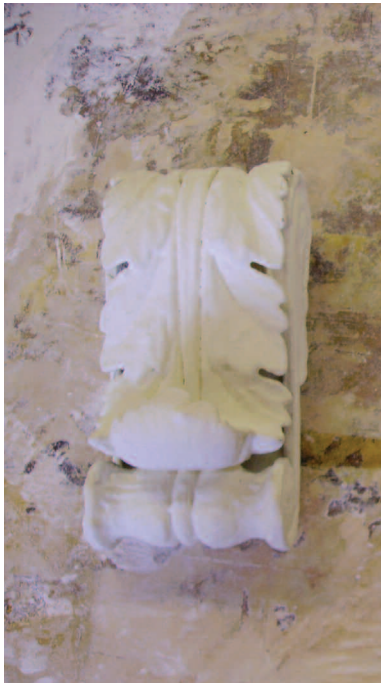
Corbel before cleaning.

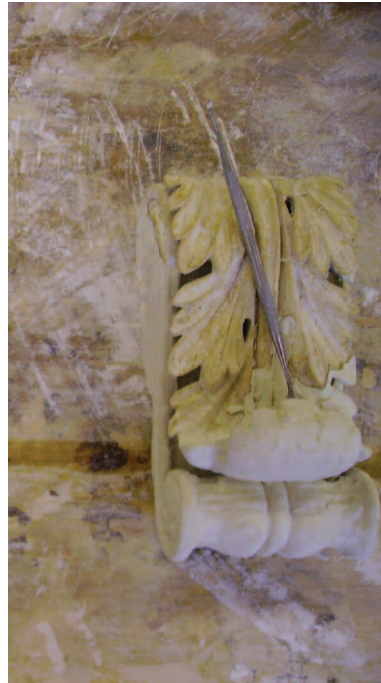
Corbel after cleaning.

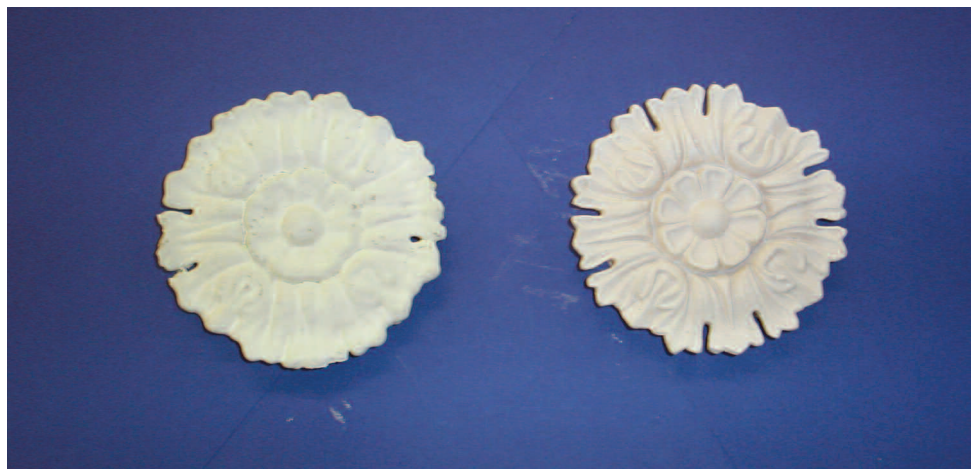
Flower before cleaning

Flower cast from mould

Enrichments were removed and layers of historic paint painstakingly removed using just steam and small picking tools and so revealing the original detail of the enrichments. Moulds were then taken of the enrichments and new mouldings cast and fitted where required.

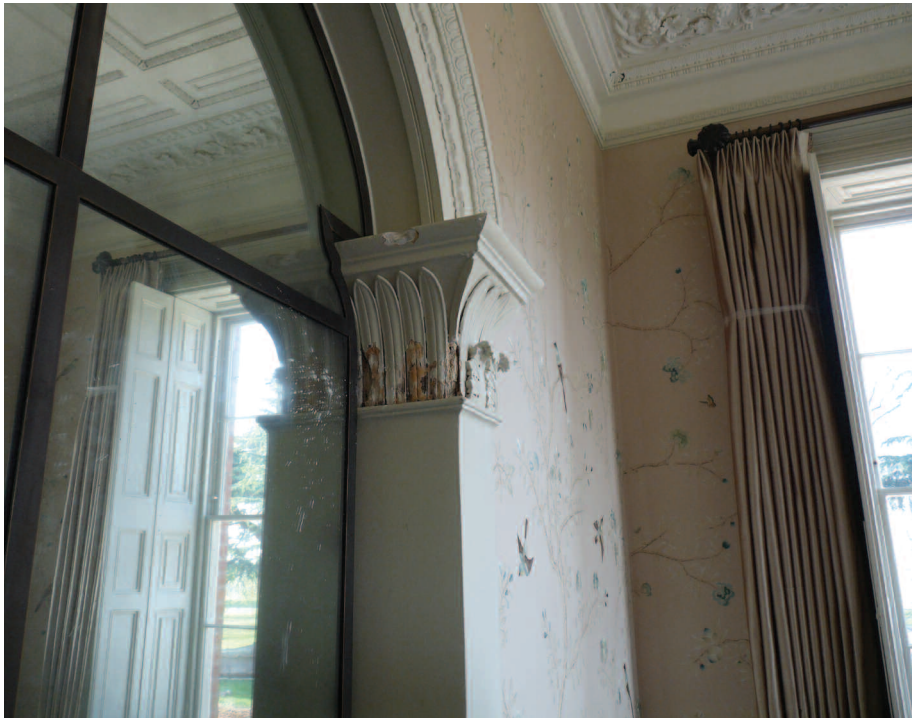
Existing damaged plaster capital.  
The damaged waterleaf and acanthus leaves were removed  
A sample was taken and cleaned up.  
Silicon rubber was used for a new back and face mould

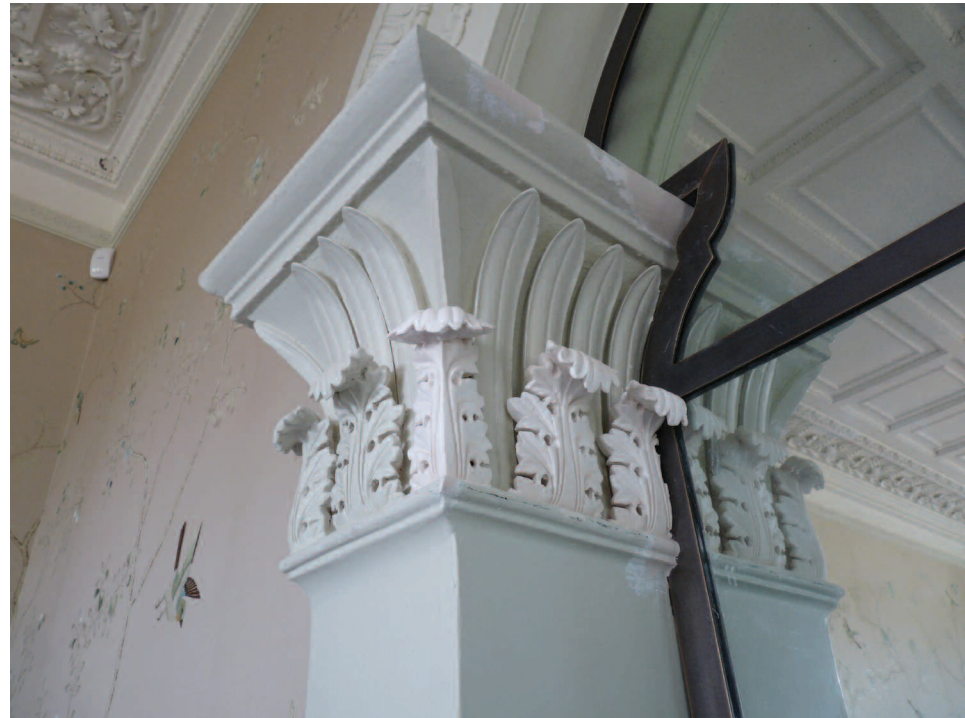
The restored plaster capital.

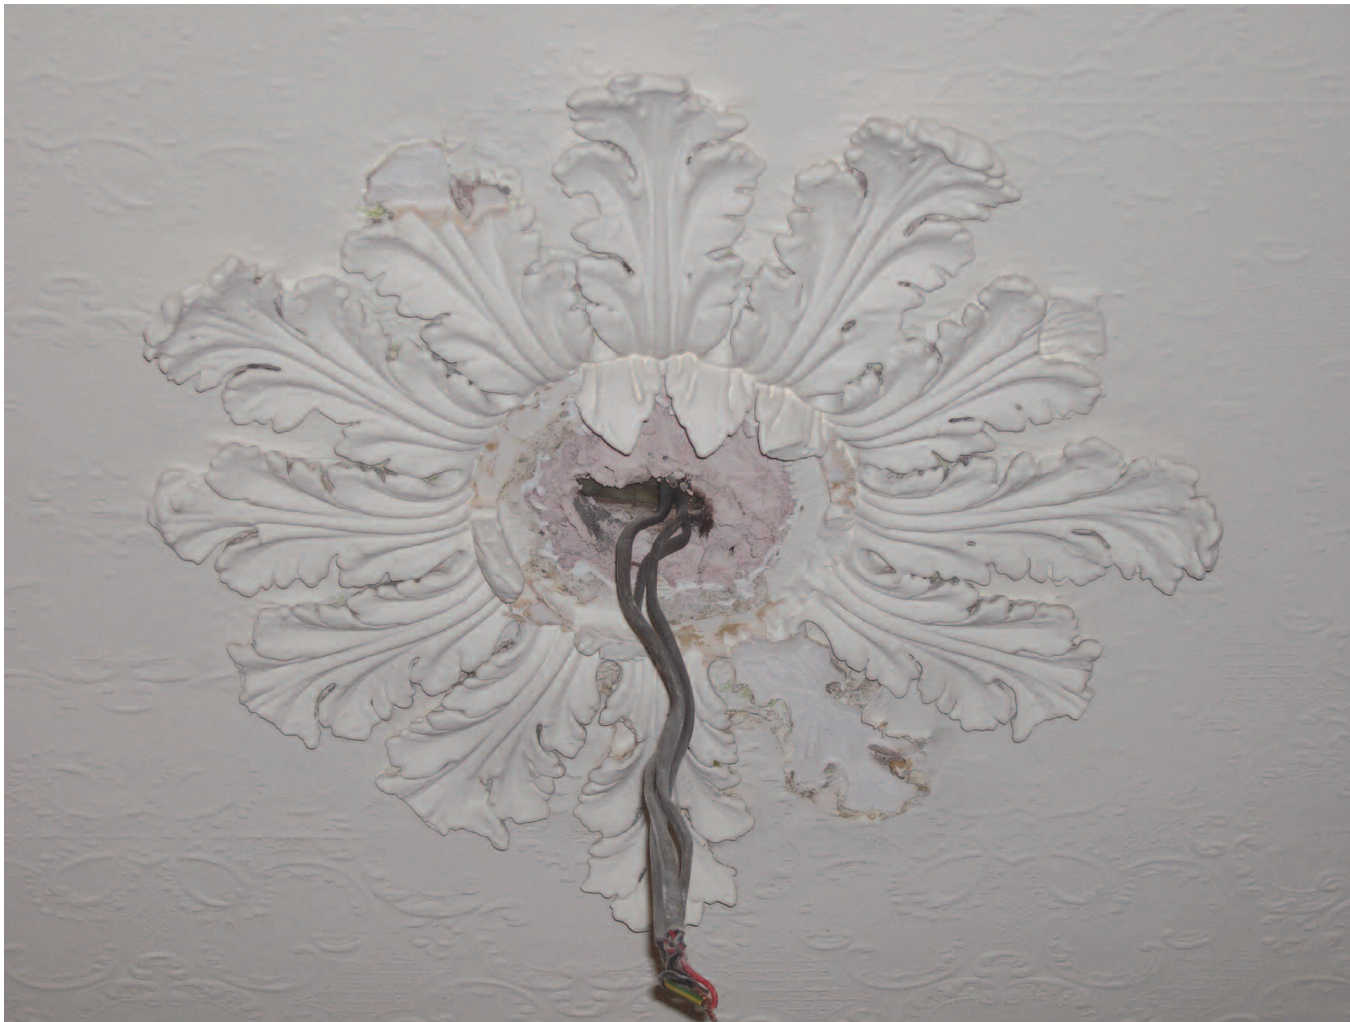
Existing damaged ceiling rose required remodelling in clay to match with the original.

A sample was taken and cleaned up.

Silicon rubber was used on a new back and face mould.

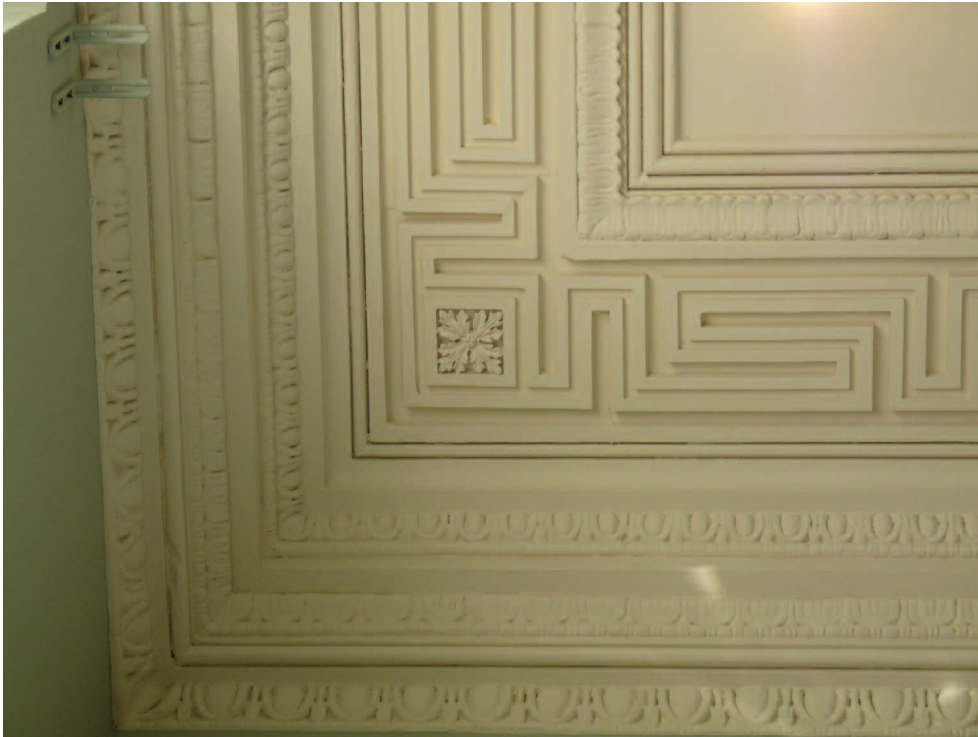
Repaired mouldings.

Repairs to mouldings, especially ceilings and cornices were required in fifteen rooms, all in varying states of disrepair. Some simply required repairs by hand, others required enrichments remodelling and some needed complete sections replaced to match original.

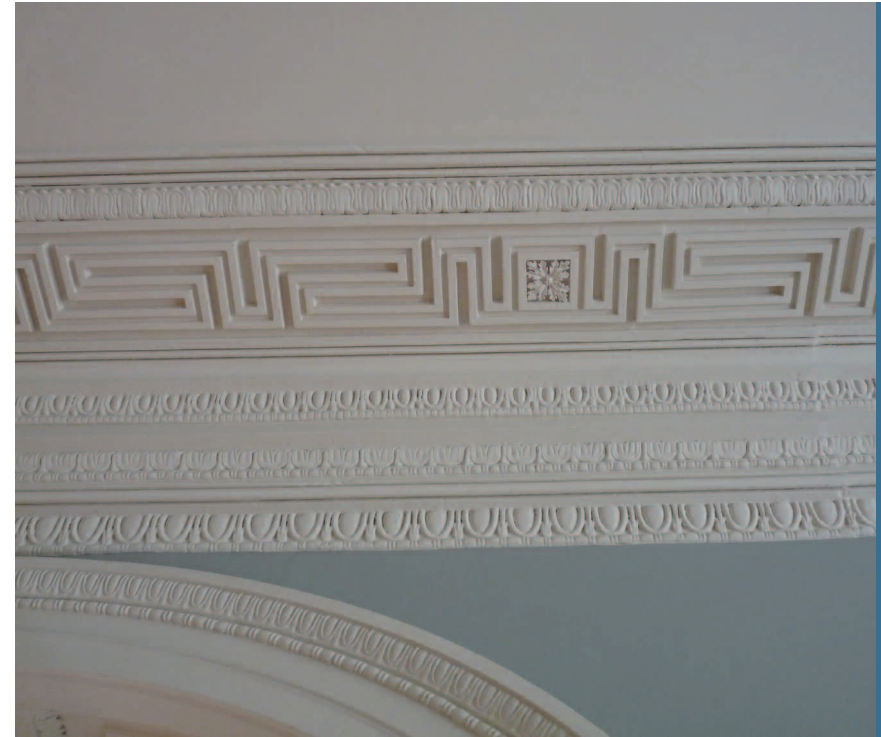
New enrichments bedded in complete new section.
